WEST HILL POND DAM

CT. 00377

PHASE I INSPECTION REPORT
NATIONAL DAM INSPECTION PROGRAM

JANUARY 1979

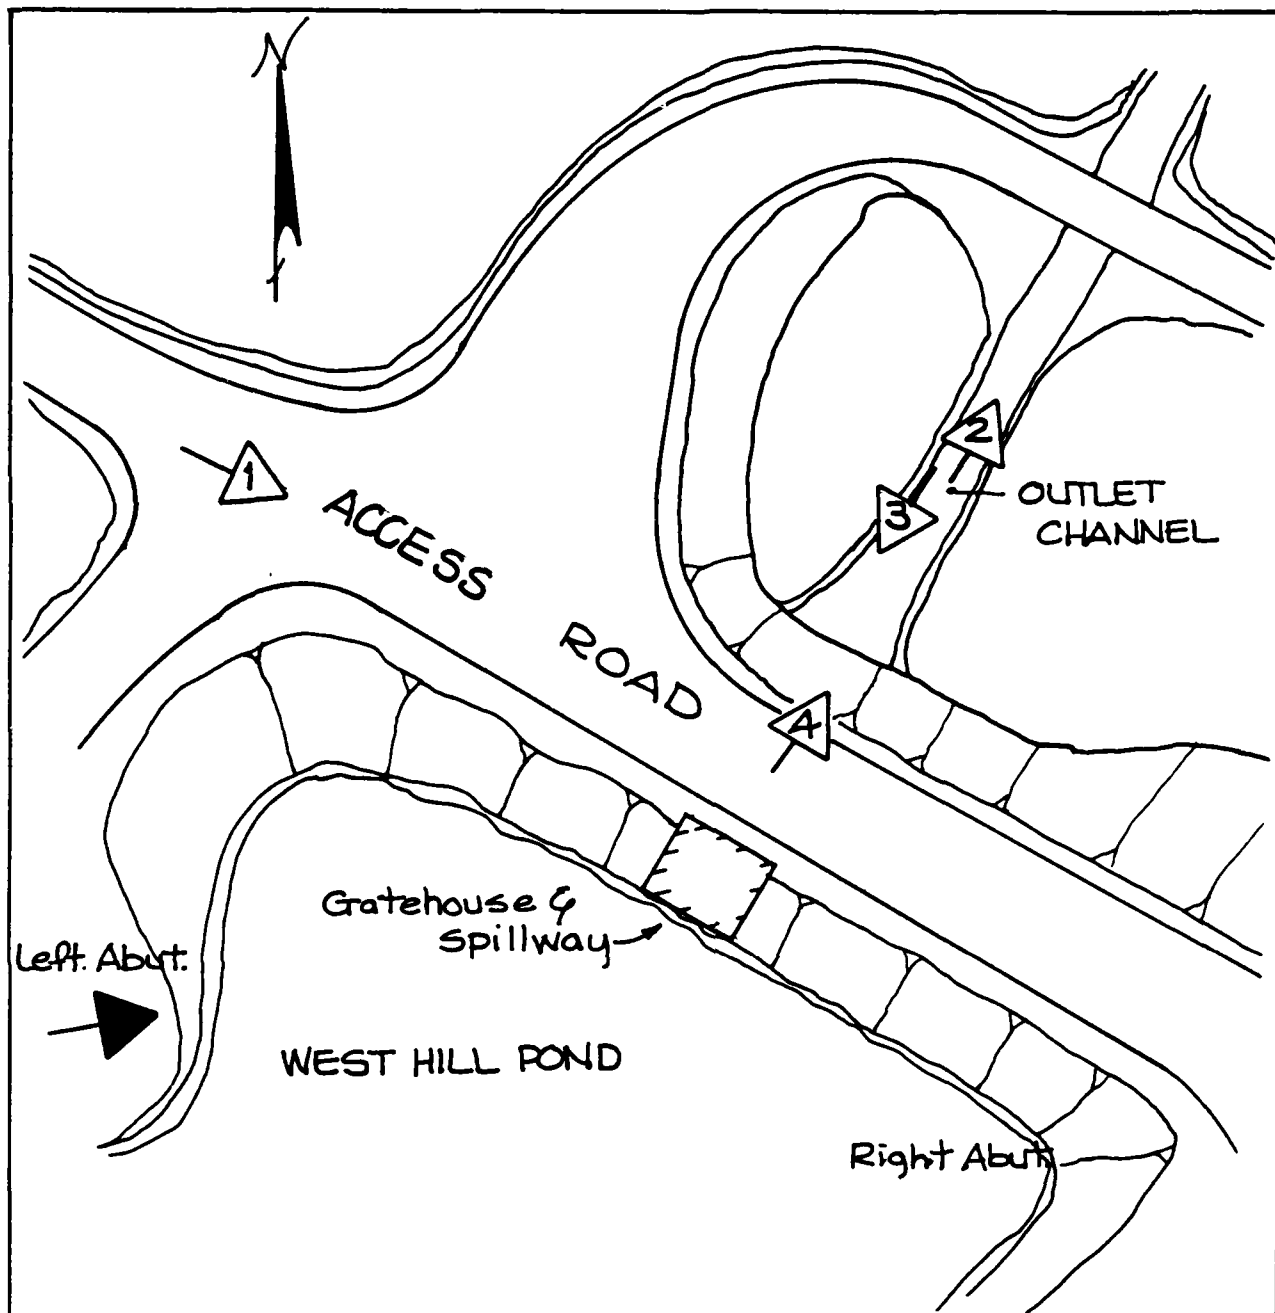
- ▲ Appendix "C"
 Photos
 ► Overview
 Photo

The dam is essentially a highway embankment of earth and stone closing off the outlet of the lake. The dam is about 200 ft. long and 10 ft. high, with a 30 ft. wide paved roadway (Appendix C, Photo No. 1). It is surmised that the original dam had a narrower top width and that it was widened downstream at some later time to accommodate the roadway.
